**FINAL REPORT - SURFACE WASTE
PILES SOURCE CONTROL
DEMONSTRATION PROJECT**

**MINE WASTE TECHNOLOGY PROGRAM
ACTIVITY III, PROJECT 10**

February 2002

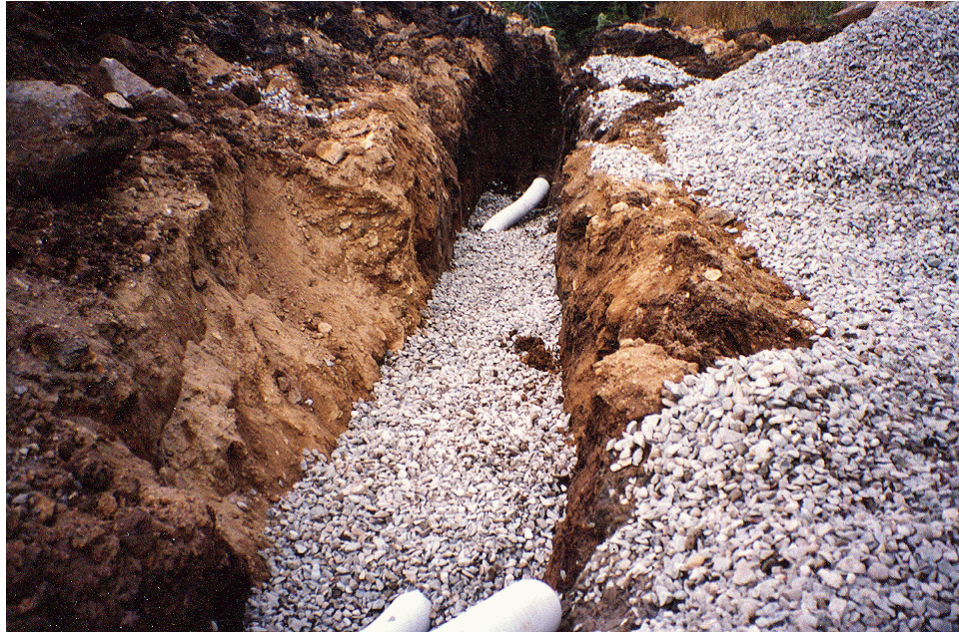
Figure 4-2. The French drain trench with the 6-inch slotted HDPE pipe wrapped in geotextile and partially covered with 1-1/2-inch minus gravel.

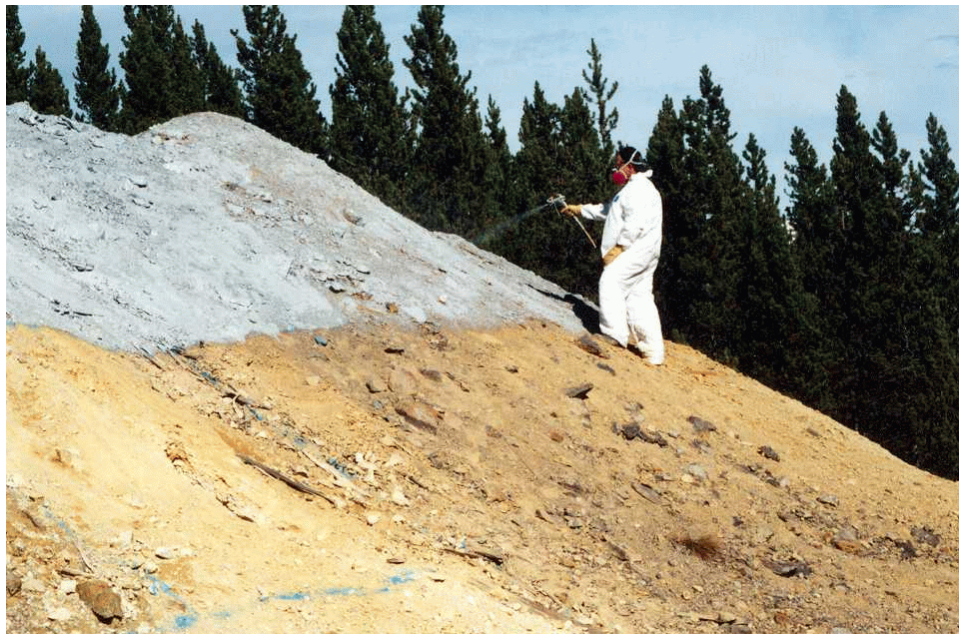
Figure 4-3. 4994 KOBathane grout being applied directly onto the surface waste pile (without a jute layer).

General Polymers 4994 KOBathane grout was spray applied onto the pile to prevent infiltration of precipitation (see Figure 4-3). This grout is a two-component aromatic membrane, urethane. Approximately 930 gallons of 4994 KOBathane grout were applied, which covered an area of 16,828 square feet. After applying the grout, the pile was covered with a heavy woven jute and burlap material. A surface water drainage ditch and collection channel were constructed at the base of the grout cover to gather runoff precipitation and direct water away from the pile. The channel dimensions were approximately 640 feet long by 6 feet wide by 2 feet deep. A 40-millimeter (mm) linear low-density polyethylene (LLDPE) liner was used to line the channel. The liner was tied into the surface waste pile underlying the grout cover to prevent seepage into the pile at the seam.

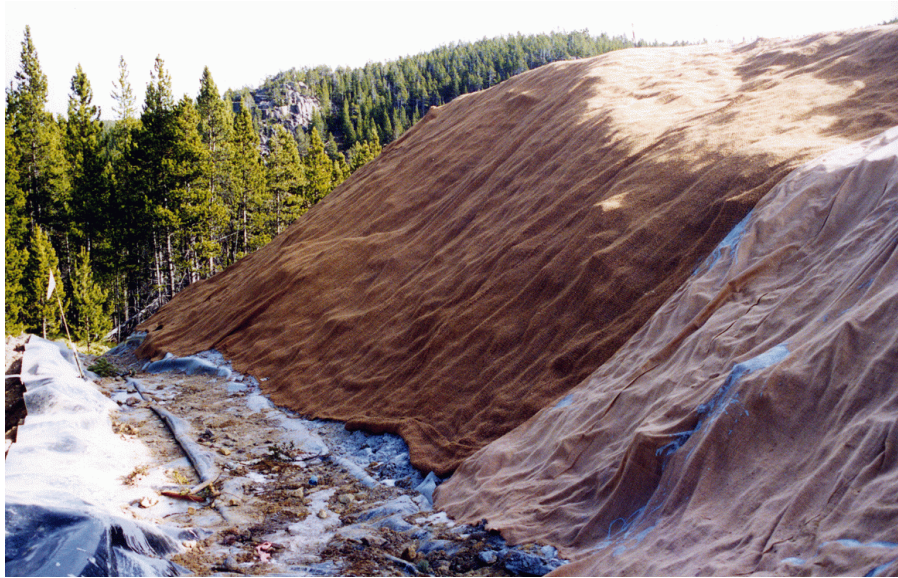
Figure 4-4. Surface water drainage ditch and collection channel with LLDPE liner and the surface waste pile covered with the final jute layer.

To prevent water seepage into the surface waste pile, a 40-mm, LLDPE liner was installed along the surface water collection channel (see Figure 4-4). The liner was received as a single 8-foot-wide by 688-foot-long roll. To place the liner in the ditch, the liner had to be spliced in several places and welded together. Sections of approximately 50 feet were cut from the roll and were placed in the collection channel. Each section was then aligned with the previous section end and welded together to create a leakproof seam. This continued until the collection channel was completely lined with the LLDPE. Next, a small 6-inch ditch was constructed along the upper edge of the liner for a tieback. The liner was then placed into the ditch and covered with material from the waste pile. The other edge of the liner was draped over the lower edge of the collection channel and was secured in place using the same method that was used for the upper edge of the channel. The collection channel completely encircled the surface waste pile. At the downhill side of the surface waste pile, a discharge outlet was constructed to allow the runoff precipitation to be measured and then transported away from the surface waste pile.

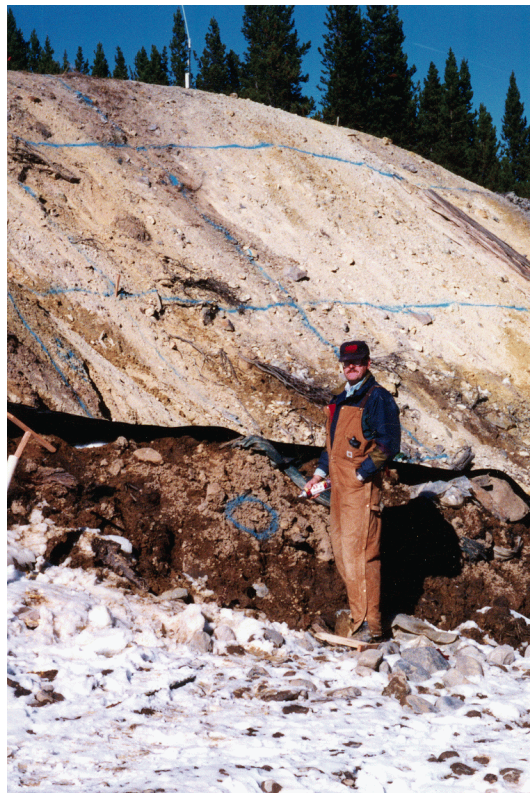
Figure 4-5. Division of the surface waste pile into 100 square foot sections for spray application of grout.

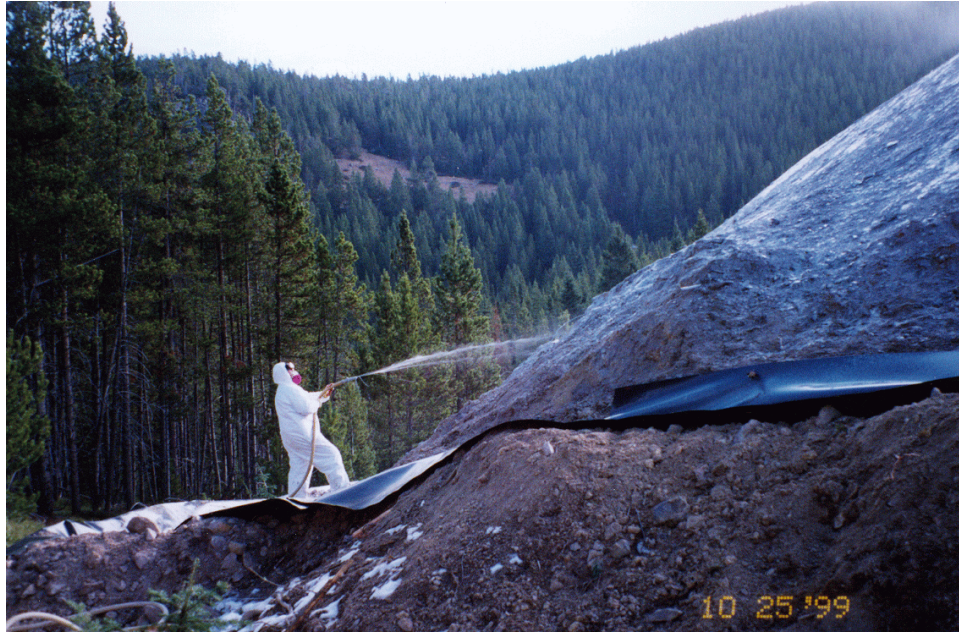
Figure 4-6. Spraying grout directly onto the surface waste pile without the jute material.

- 4) It was observed that application of the grout directly to the surface waste pile was fairly successful. Many of these spray-applied areas achieved a seal that served to stabilize the surface waste pile; however, voids were visible around larger rocks. Spraying directly onto irregular surfaces increased the amount of material used because of the increased surface area. The application time and cold weather also made it difficult to make the cover impervious.

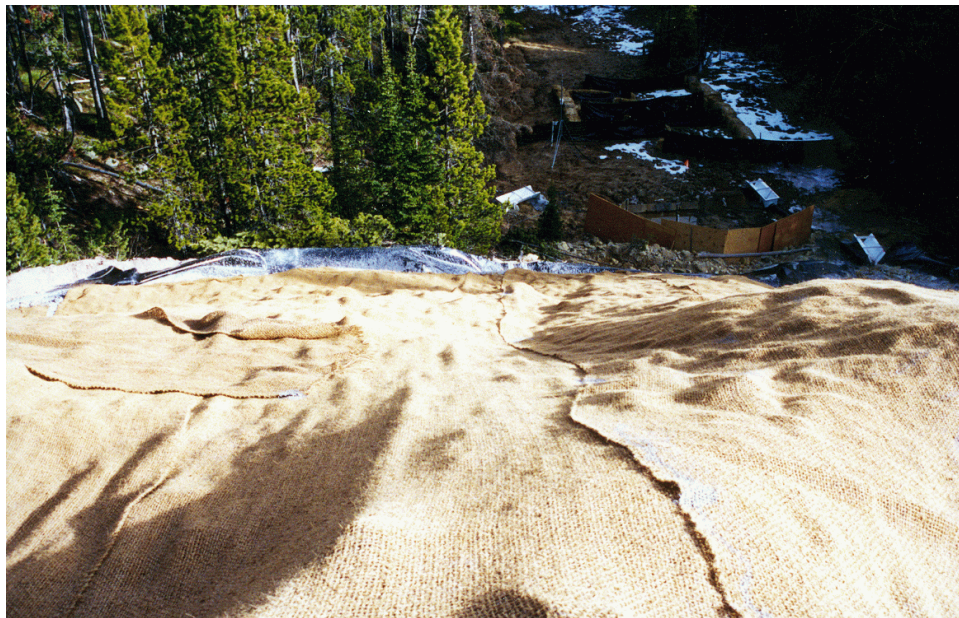
Figure 4-7. Jute material applied to the surface waste pile.

To prevent damage to the grout cover, an additional 3/4-inch webbed, jute material was applied to the pile (see Figure 4-7). This jute material was secured at the top and then rolled down each side. The jute material was overlapped 1 foot on both sides of each section to ensure the pile was completely covered. The initial project design specified that seeded topsoil be placed on top of the jute (see Figure 4-8). However, the seeded topsoil cover was eliminated because the surface waste piles at the
